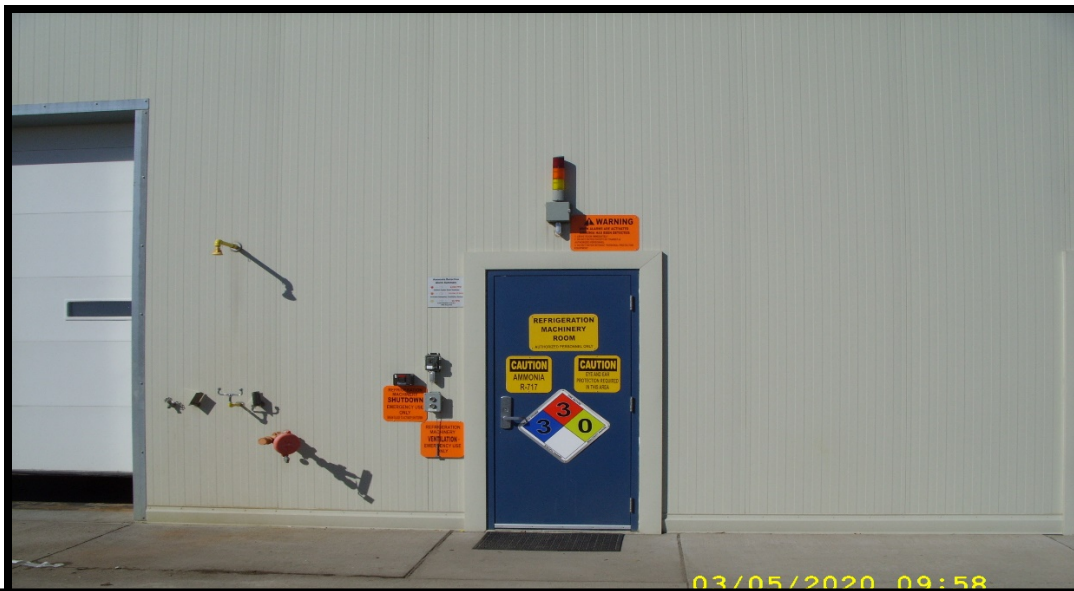
Outside entry door to the engine room at the DMCSC site. Notice the visual light tower, centered, above the door. You can see appropriate signage, emergency shower and eye wash station to the left. An emergency shutdown box, ventilation fan activation box, and an ammonia sensor monitor located directly to the left of the door, above the two orange signs.

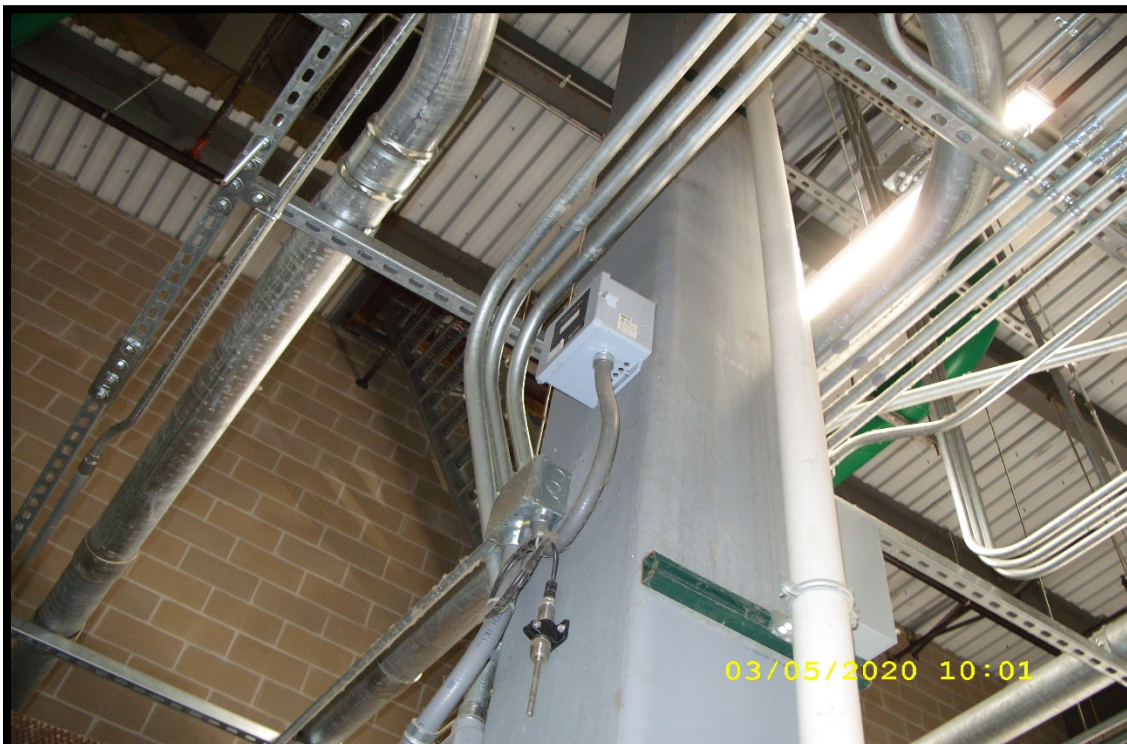
One of two ammonia detectors located in the engine room. The second one is located near the exhaust fans at the ceiling of the room.,

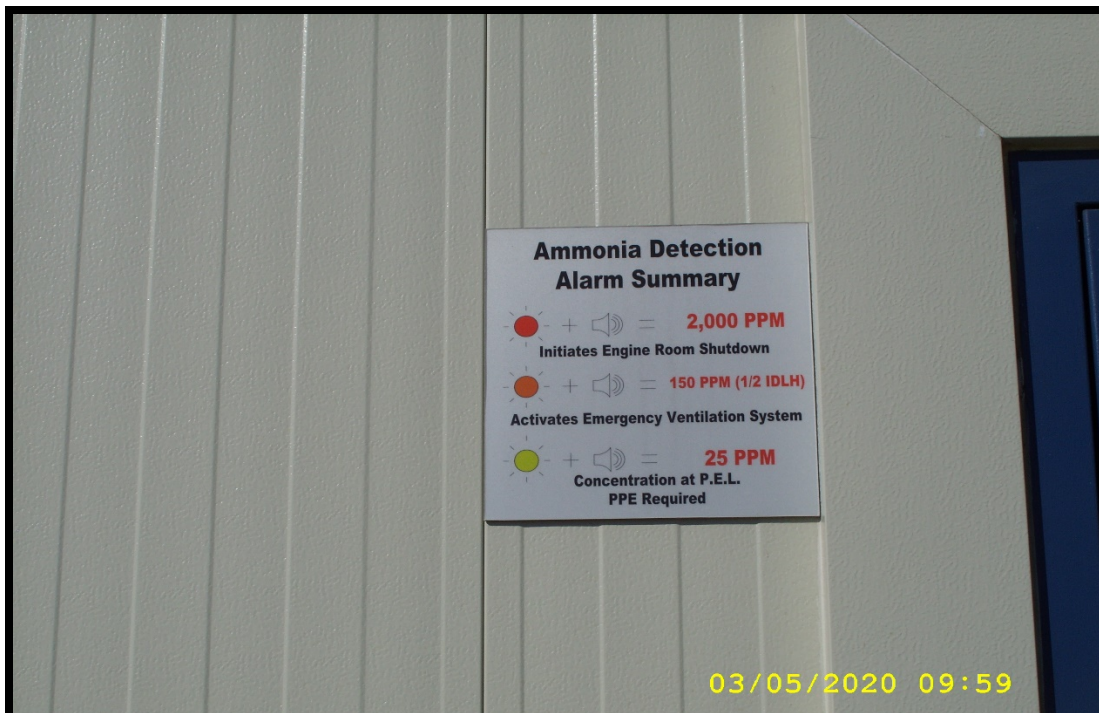
Photo of the ammonia sensor summary sign discussed in the PHA section of the report. This one is located adjacent to the entrance door to the engine room.

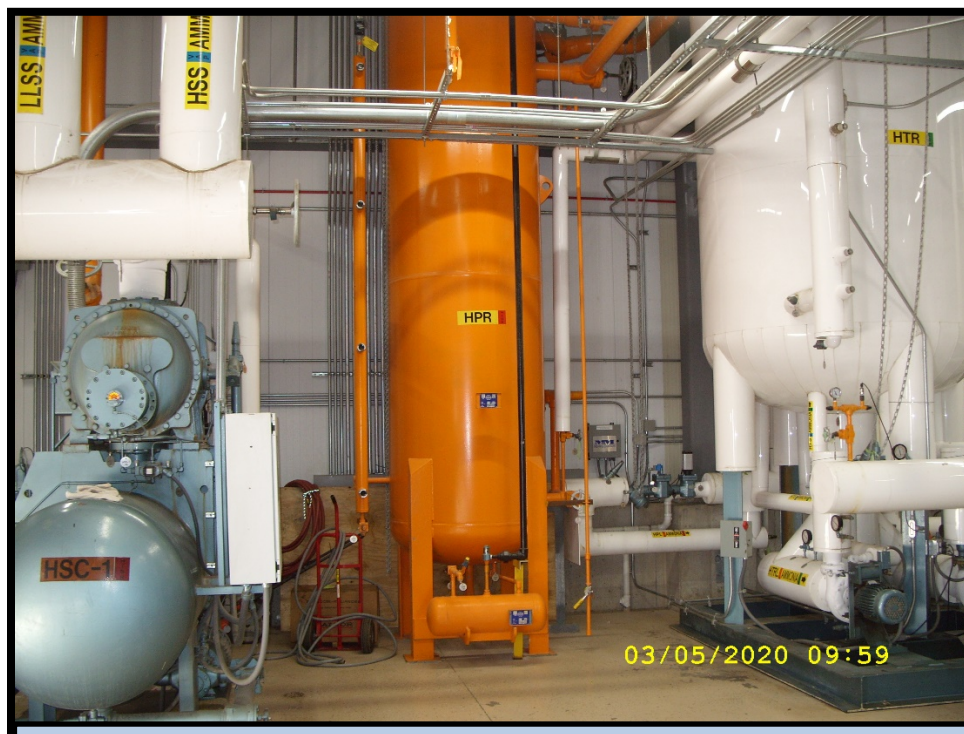
Photo inside the engine room. You can see the orange, high pressure recirculator. The white, high temperature recirculator with sight glass to the right, and to the left, the high stage compressor HSC-1.

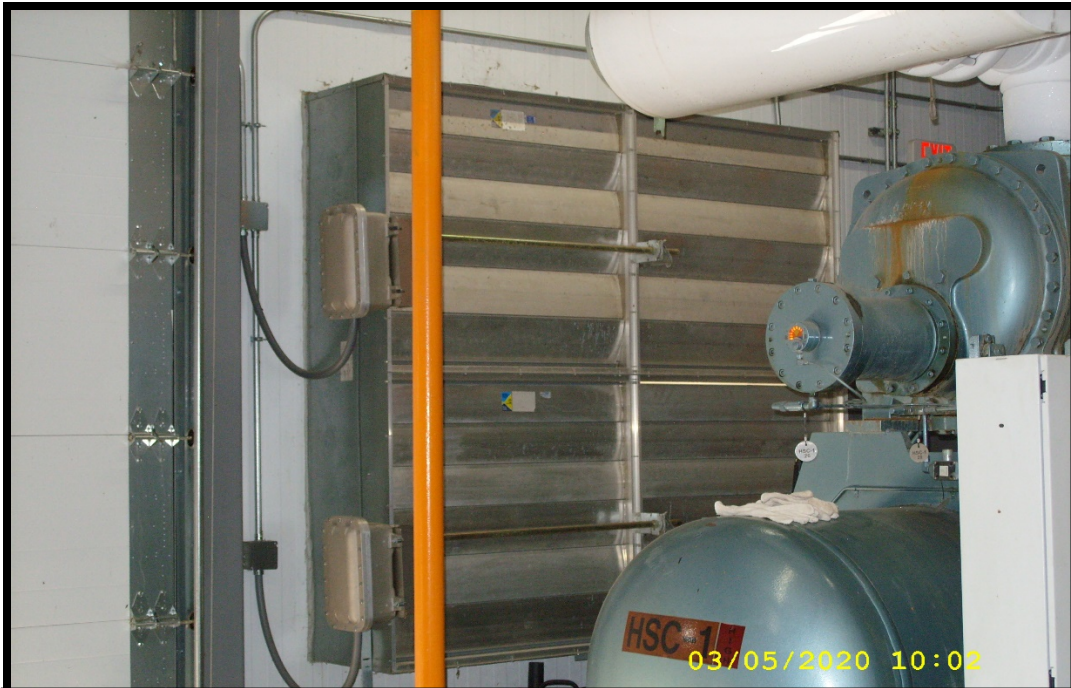
Lower set of powered louvers that open automatically when the ammonia detection system picks up a reading in the engine room of 150 PPM. An upper set of louvers, above these, would also activate to remove any ammonia from the room.

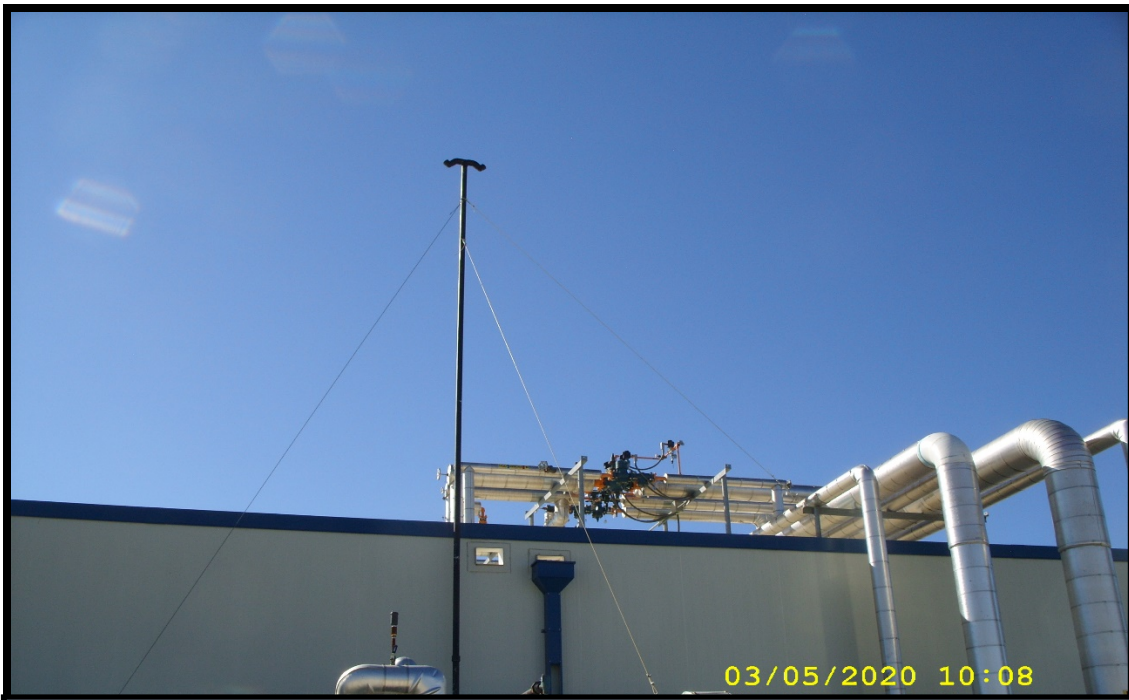
View standing next to the condenser tower looking at the vent pipe and main header that feeds the penthouses. The 3 penthouses provide cold air to the blast freezers in the facility.

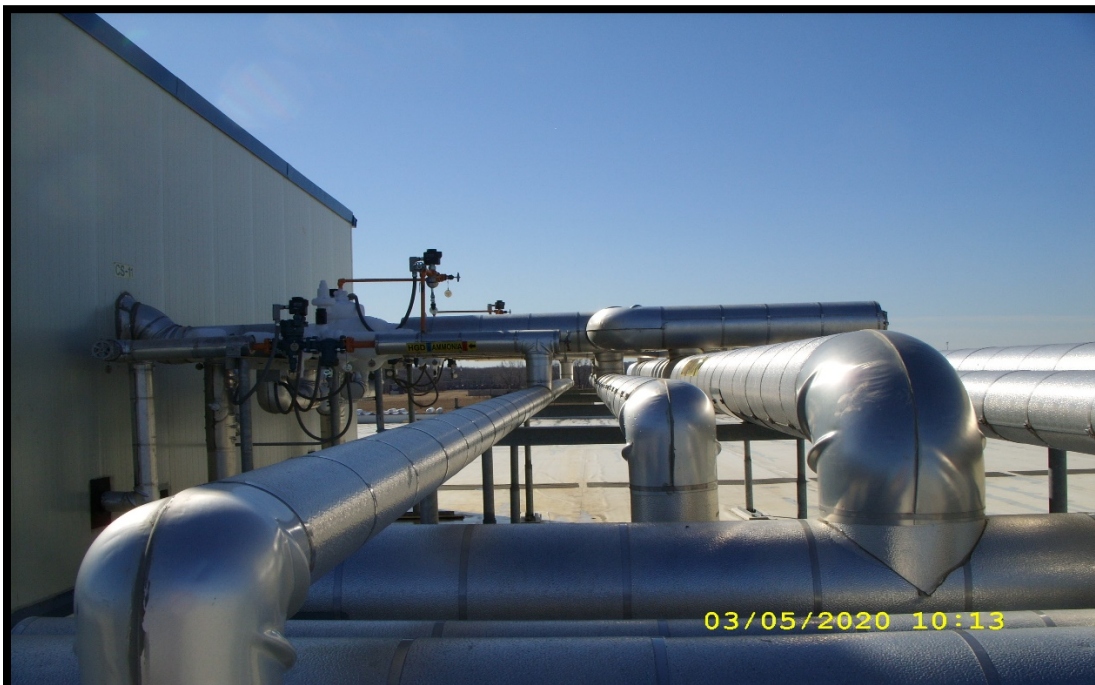
The control station for penthouse #3 located on the roof of the facility.

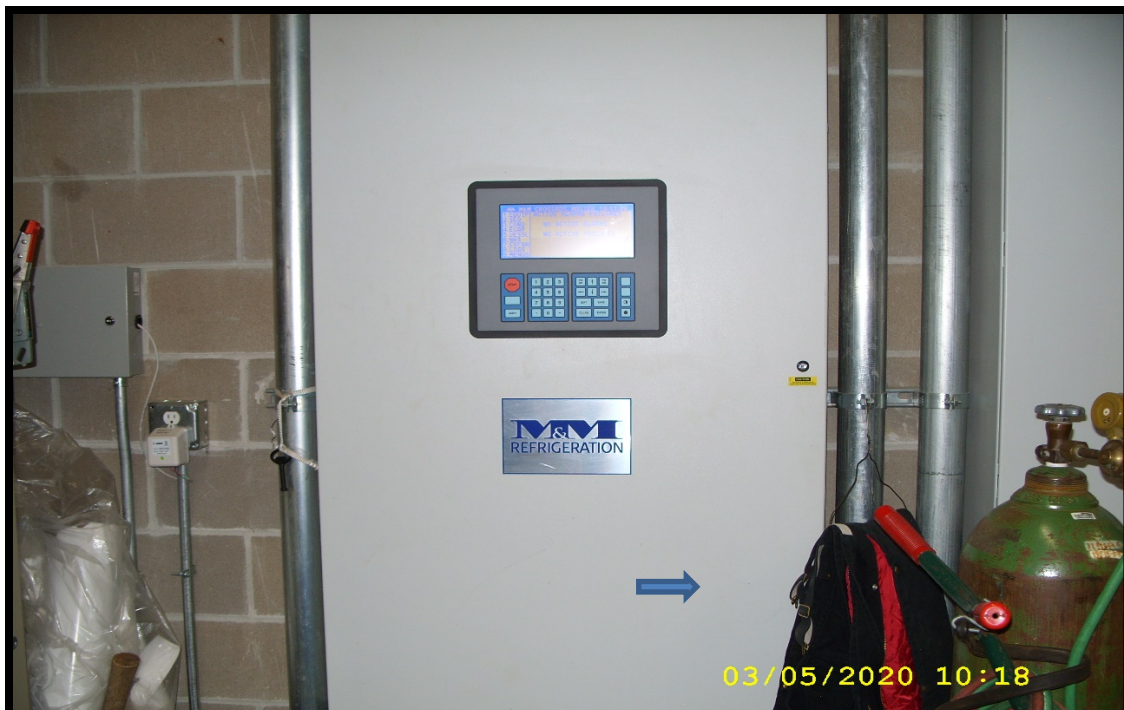
M&M main control panel for the refrigeration system, located in the electrical room of the facility.
